# UNDERWATER BRIDGE INSPECTION REPORT

STRUCTURE NO. 4260

NORTH CHANNEL OF THE MISSISSIPPI

MINNESOTA DEPARTMENT OF TRANSPORTATION  
UNDERWATER BRIDGE INSPECTION

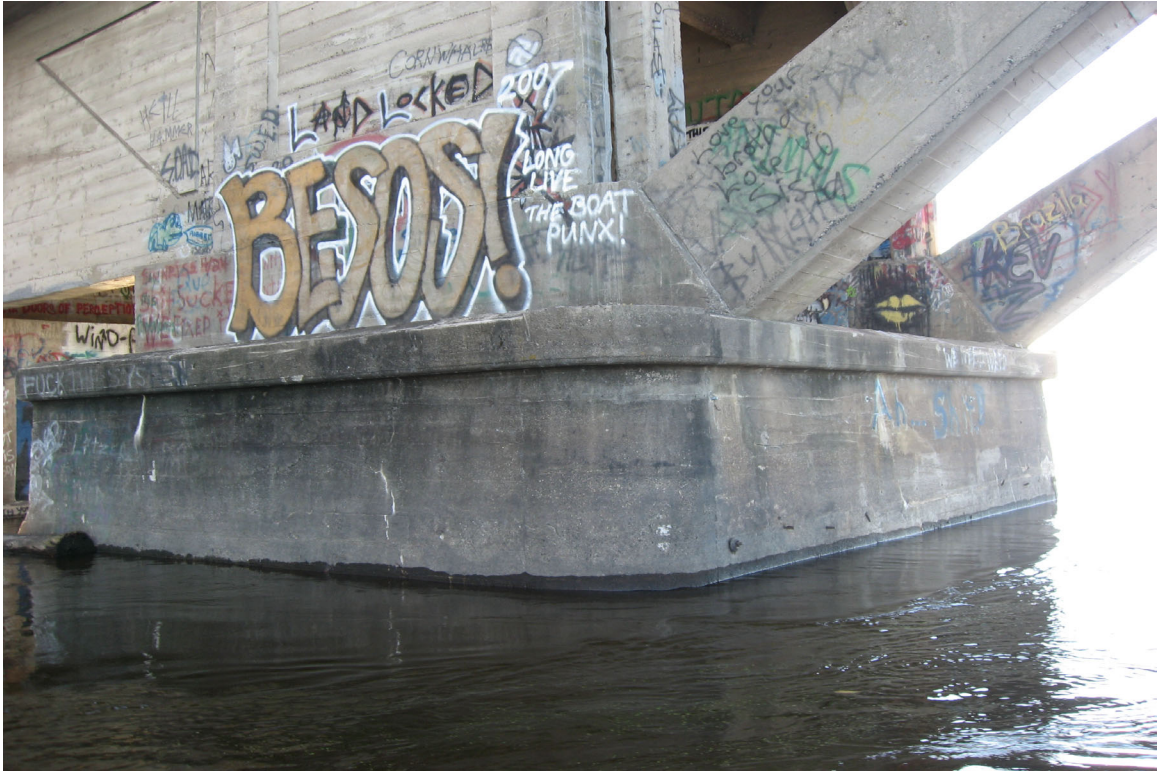
Photograph 1. View of Pier 1, Looking Southeast.

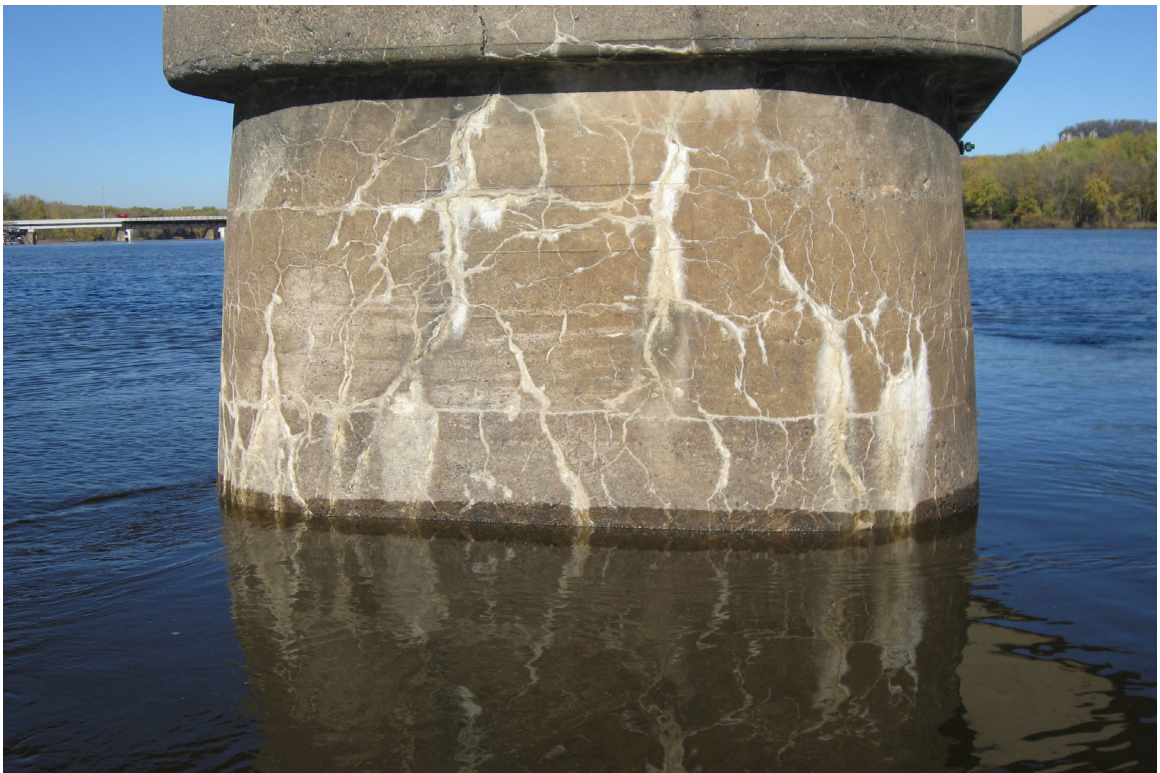
Photograph 14. View of Typical Cracking with Efflorescence.

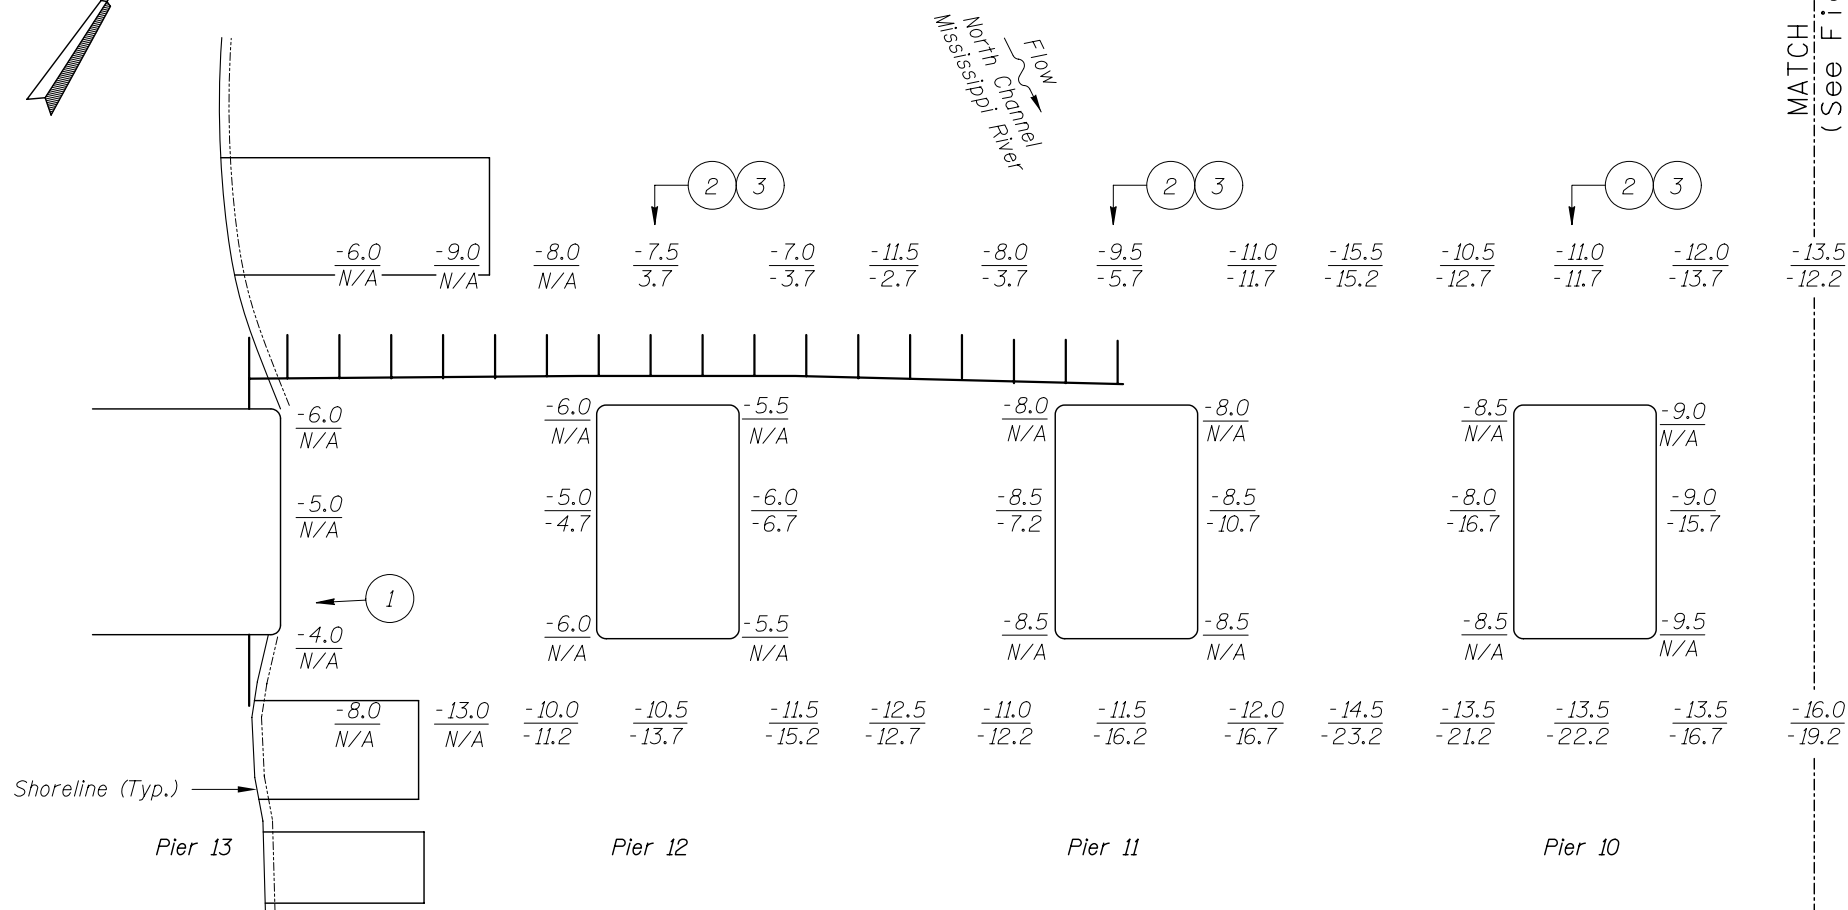
SOUNDING PLAN

- 1 The channel bottom at Pier 13 consisted of silt with small stones (no new riprap). Stone and rubble was observed at upstream and downstream ends.
- 2 The channel bottom of Piers 1 through 12 consisted of newly placed riprap typically 1 to 2 feet in diameter with a maximum diameter of up to 3 feet. It was observed around the entire perimeter of all piers typically extending to top of footing or to no lower than 2 feet below top of footing.
- 3 The submerged concrete was typically in satisfactory condition with moderate scaling from the waterline to 2 feet below the waterline with typical penetrations of 1/2 inch and maximum penetrations of up to 1 inch. Widespread random vertical and horizontal hairline cracks with efflorescence were also observed on the concrete surfaces throughout pier shafts.

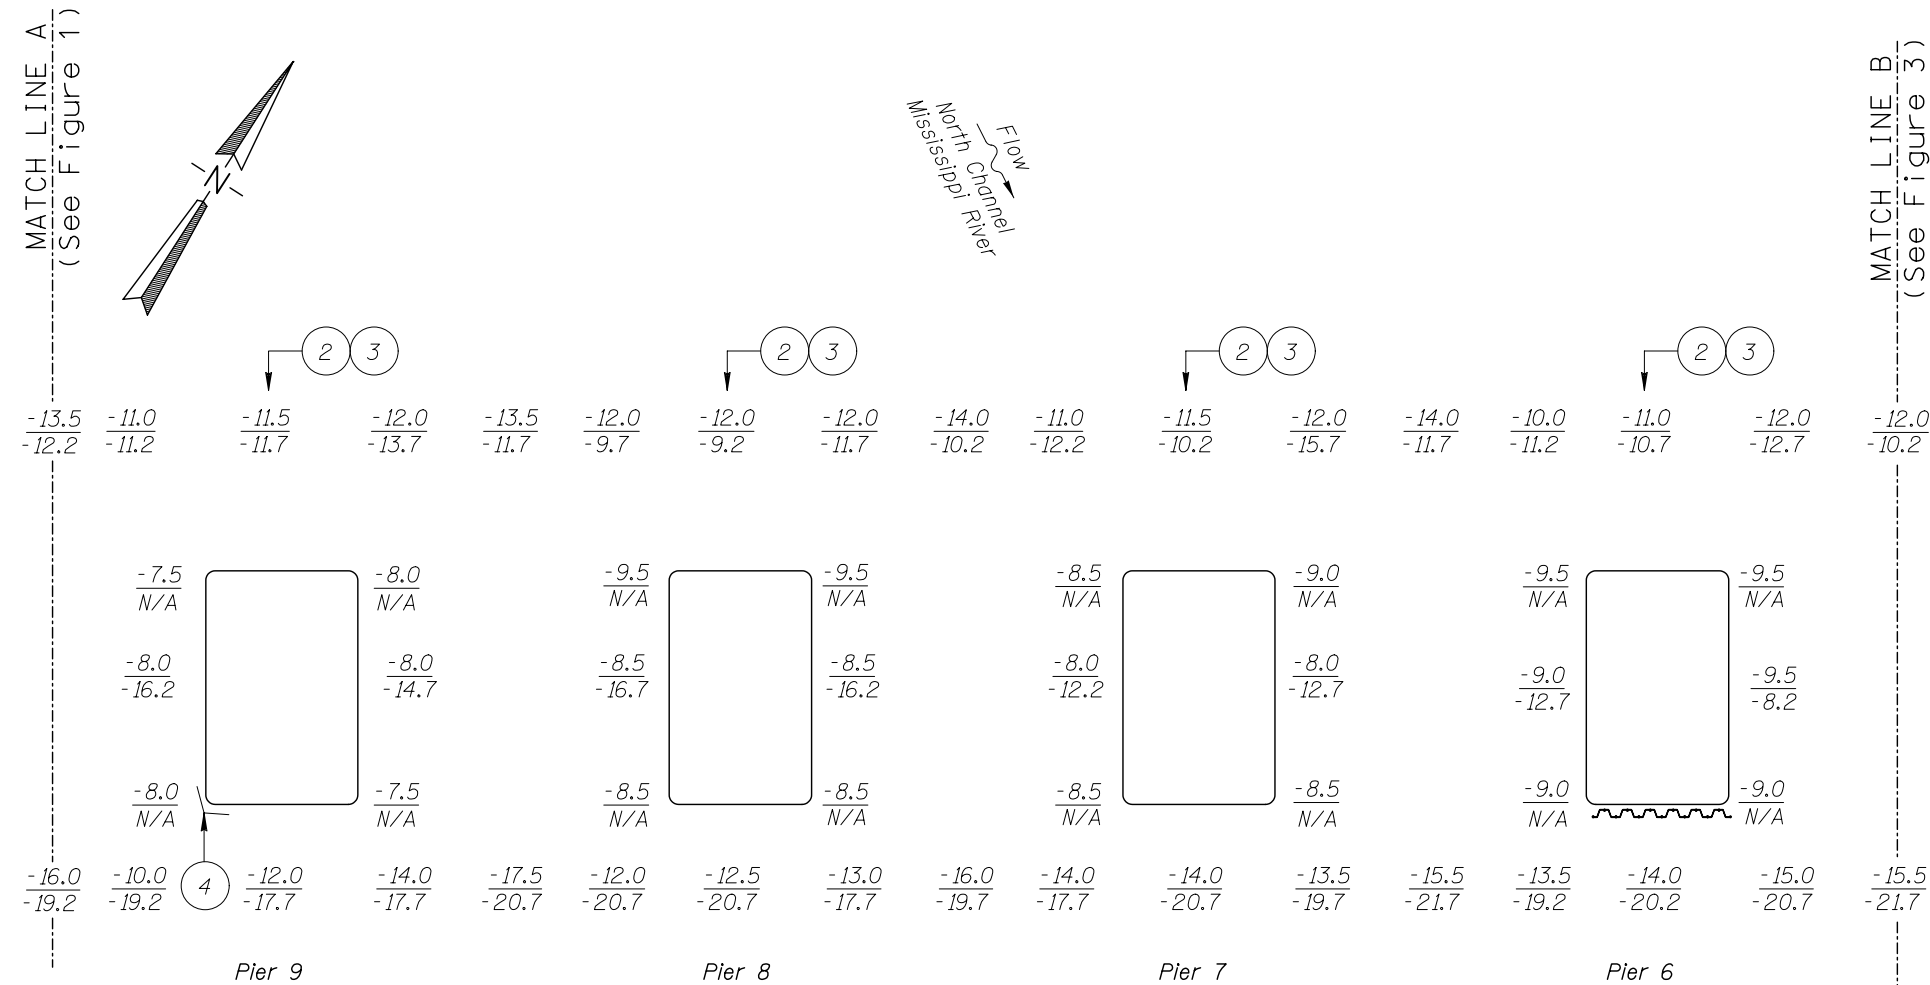
SOUNDING PLAN

- 2 The channel bottom of Piers 1 through 12 consisted of newly placed riprap typically 1 to 2 feet in diameter with a maximum diameter of up to 3 feet. It was observed around the entire perimeter of all piers typically extending to top of footing or to no lower than 2 feet below the top of footing.
- 3 The submerged concrete was typically in satisfactory condition with moderate scaling from the waterline to 2 feet below the waterline with typical penetrations of 1/2 inch and maximum penetrations of up to 1 inch. Widespread random vertical and horizontal hairline cracks with efflorescence were also observed on the concrete surfaces throughout all pier shafts.
- 4 Pier 9 exhibited an area of section loss on the downstream west corner from 1 foot below to 3 feet below the waterline with up to 2 inches of penetration.

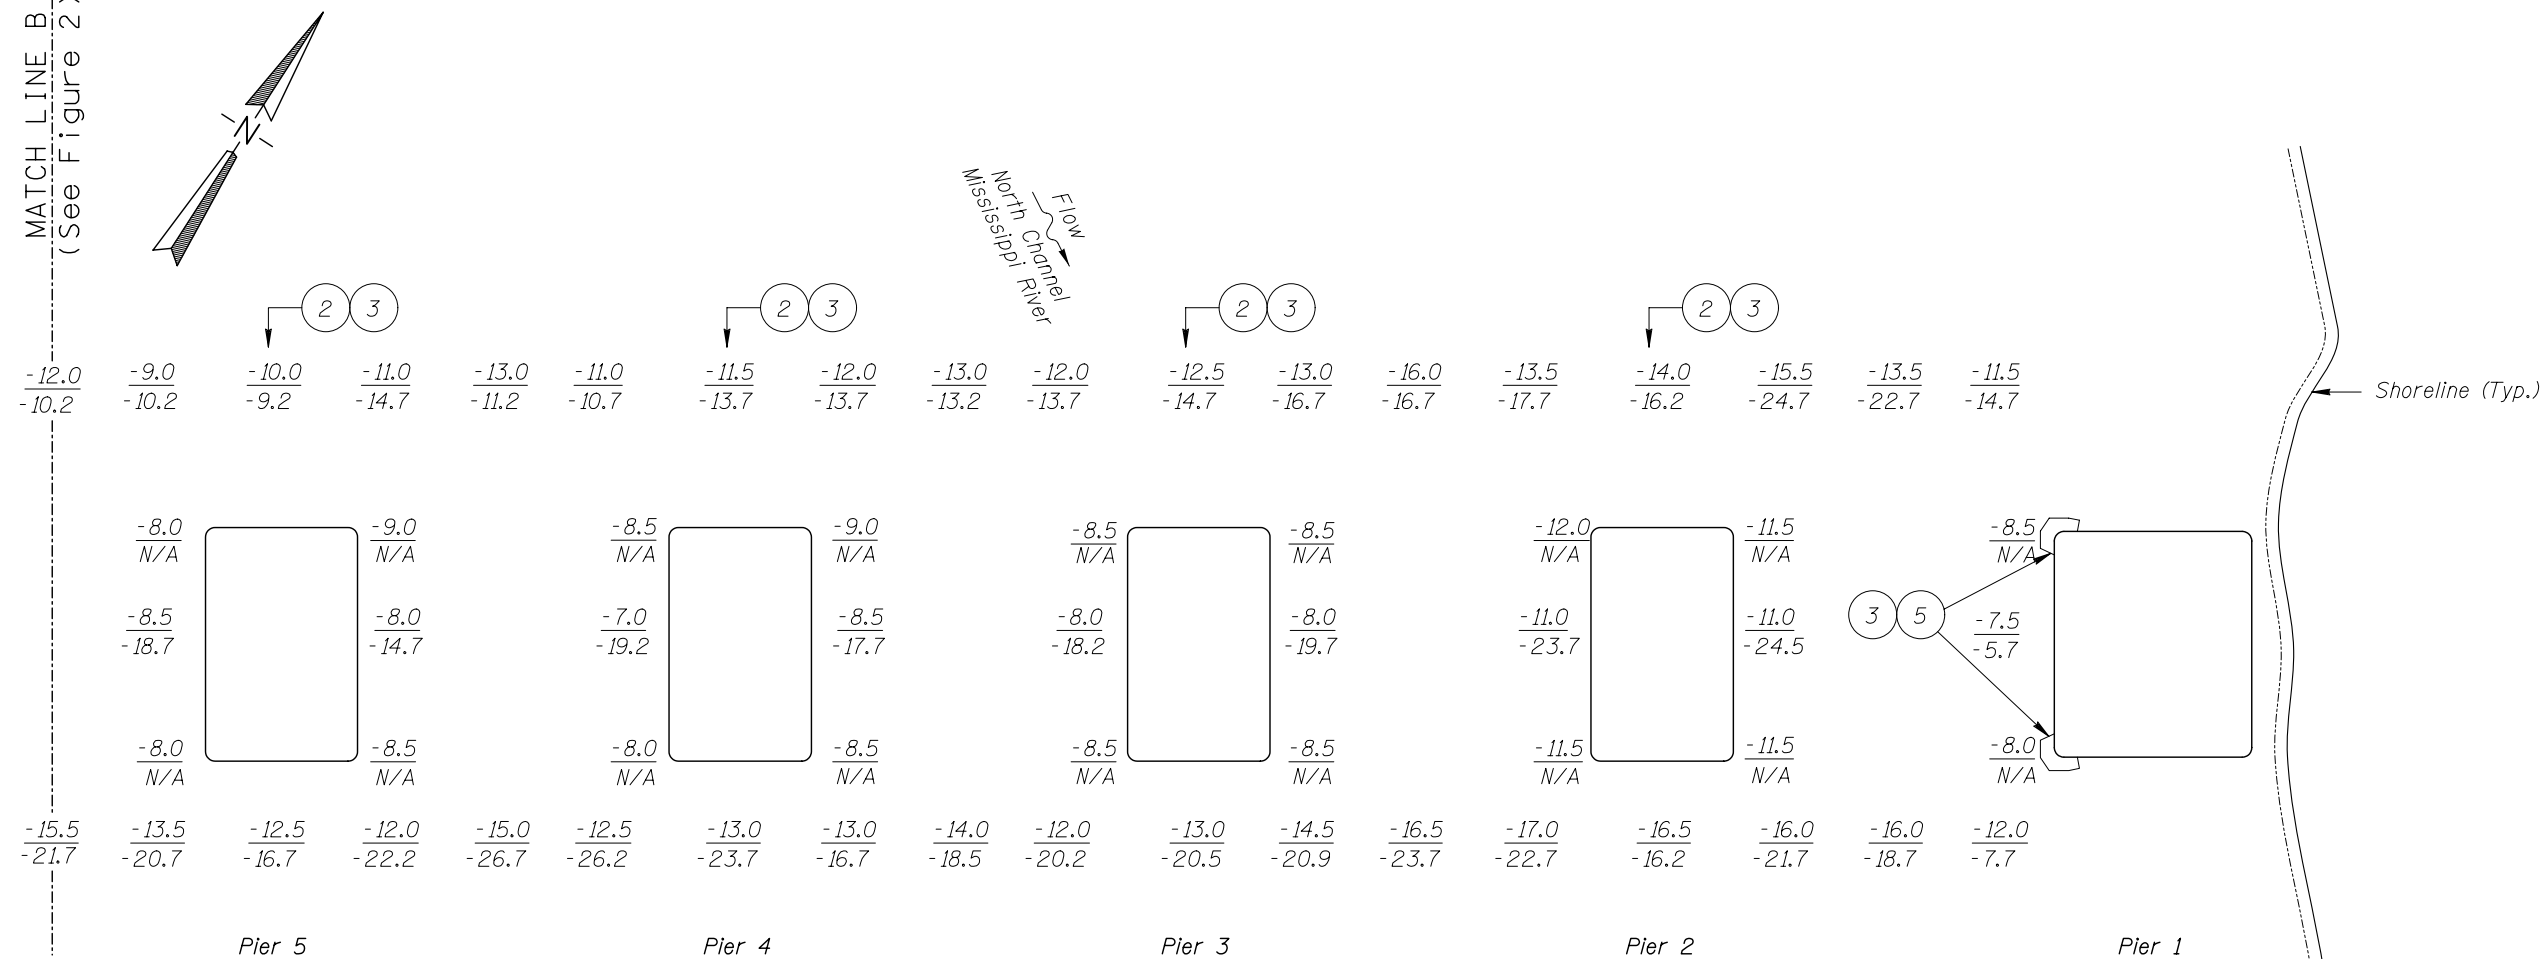
### SOUNDING PLAN

- 2 The channel bottom of Piers 1 through 12 consisted of newly placed riprap typically 1 to 2 feet in diameter with a maximum diameter of up to 3 feet. It was observed around the entire perimeter of all piers typically extending to top of footing or to no lower than 2 feet below top of footing.

- 3 The submerged concrete was typically in satisfactory condition with moderate scaling from the waterline to 2 feet below the waterline with typical penetrations of 1/2 inch and maximum penetrations of up to 1 inch. Widespread random vertical and horizontal hairline cracks with efflorescence were also observed on the submerged concrete throughout all pier shafts.

- 5 The top of the footing at Pier 1 was exposed at the upstream (3 feet vertical exposure) and downstream (1 foot vertical exposure) corners. 2 feet diameter riprap was observed up against the footing.

- 6 At the upstream half there is a row of 5 to 6 timber piles next to the footing and old formwork.
